INNOVATION PROFILE

Aston Station

Mitigating Erosion Around Troughs

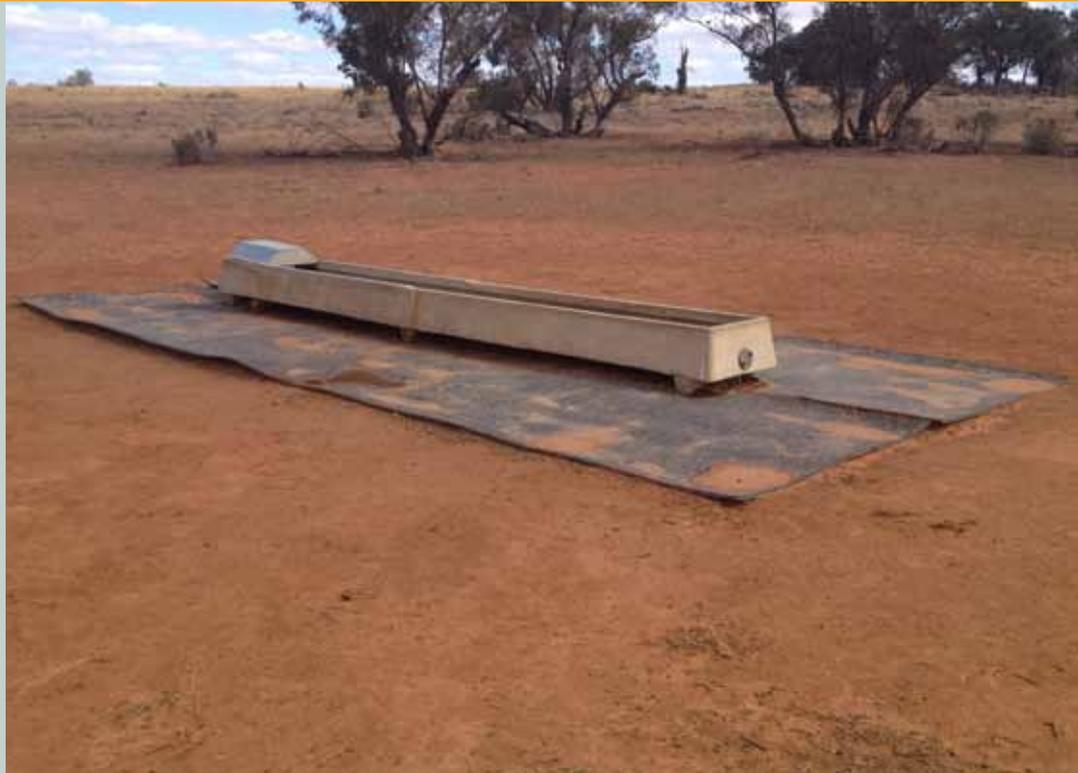
Figure 1: A trough on Aston Station with conveyor belt used to reduce erosion.

Through opportunity, the farm also acquired a significant length of rubber conveyor belt, approximately 1.4m wide by 150 to 200mm thick from a nearby mine. This was cut into two strips, longer than the trough, and laid beneath some of the straight concrete troughs, which hold the strip in place (see figure 1).

A key benefit of this innovation is that it is almost a no-cost solution, utilising free recycled rubber. Often other solutions, such as concreting aprons around water troughs, only shifts the erosion area and this does not occur in the Ingram's approach. They have also reduced ongoing maintenance of the troughs, with little erosion noticed at the edge of the conveyor belt.

The Ingrams have found that the conveyor belt method has been more successful at controlling erosion than the car tyres to date.

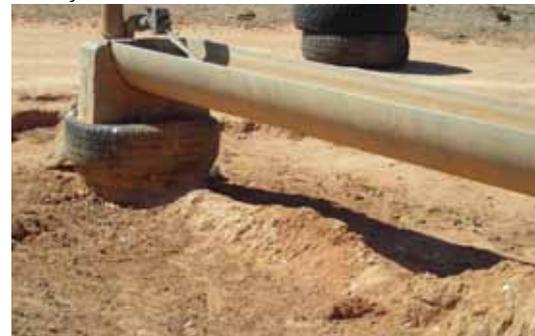
Figure 2: A water trough without rubber tyres or conveyor belt around the base.

The Ingrams have buried old car tyres around their cup and saucer troughs to reduce the level of erosion by stabilising the soil surface. Maintenance is still required when the soil around the tyres is depleted, and needs to be replaced (see figure 2).

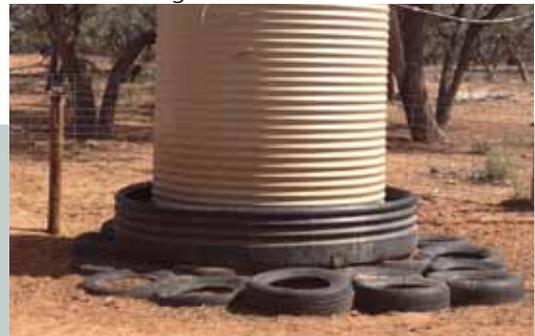
Figure 3: Cup and saucer trough with tyres at the base to mitigate erosion.

- Conveyor belt is the preferred method, as tyres require maintenance and refilling with dirt and gravel to avoid sheep getting stuck in them.
- Old rubber conveyor belt or matting could be sourced from recycling or second-hand material yards.
- If using tyres again, they would sort out similar sized (height when laid horizontally) tyres and place them together around the trough, instead of trying to fit dirt around a random assortment of tyres.
